Presenting the initial report

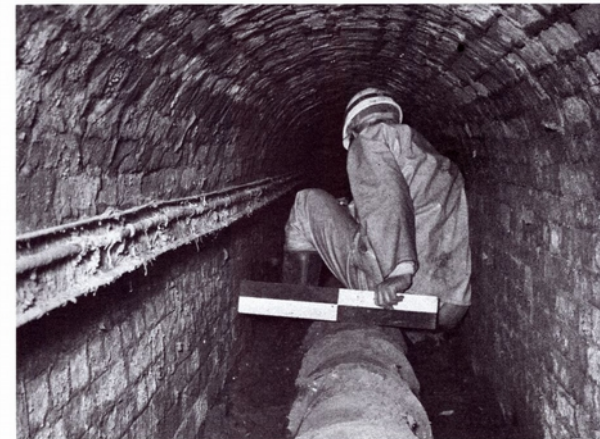
Figure 14.11 Original rainwater disposal system, St Paul's Cathedral, London, England
(Courtesy: Feilden & Mawson)

A view along the north branch before cleaning out took place. The drain was found to be blocked, causing storm water to flood over the sensitive foundations of the north-west tower. After cleaning out, the movements of the tower ceased, at least for the time being

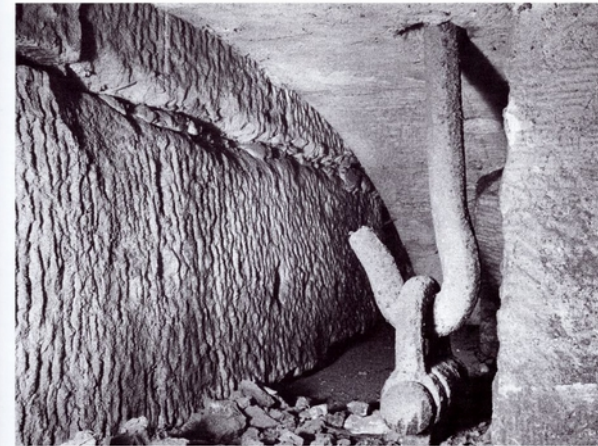
Figure 14.12 West porch, St Paul's Cathedral, London, England
(Courtesy: Feilden & Mawson)

A view inside the jack-arch on the middle cornice of the west front porch shows the Lewis bolt which appears to be in good condition: it was not known that the lintel was held up by the Lewis bolt until it was opened up

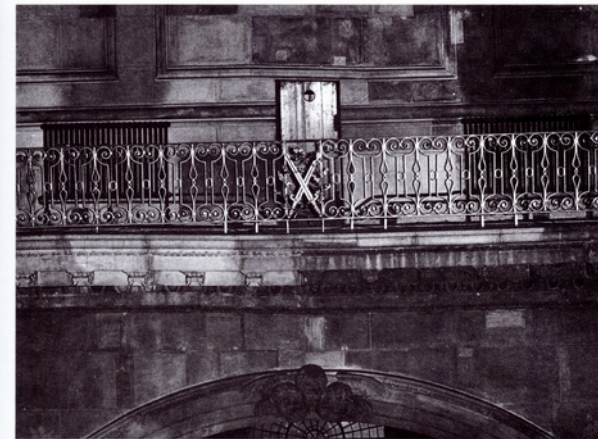
Figure 14.13 South transept, west wall, St Paul's Cathedral, London, England
(Courtesy: Feilden & Mawson)

Differential settlement in the west wall of the south transept is due to the enormous weight of the dome on the right-hand side
