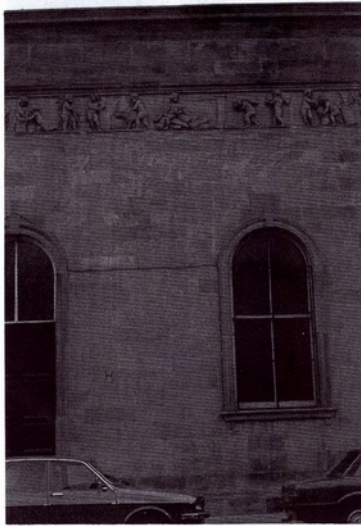
Figure 8.31 The dark coloured parapet on the Corn Exchange in Leith is typical of saturation zone staining. Water can migrate freely through free-standing features such as this, carrying soluble, staining material to the surface. Often this goes undetected until cleaning, when blame is unfairly placed on the contractor or the cleaning material

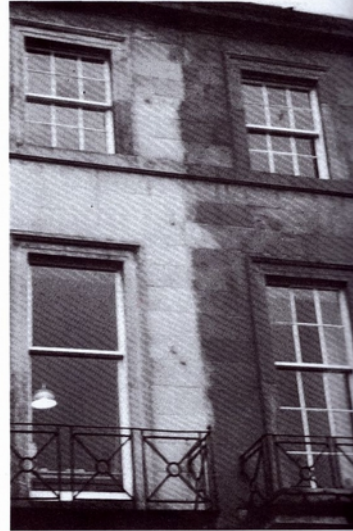
Figure 8.32 Other situations, where the cleaning material is clearly inappropriate, can be demonstrated by this illustration (above) of staining up to the party wall line on a sandstone terrace. In this case the colour of the entire unit within the facade has been changed from a cream colour to a rich orange-brown in the course of removing dirt with a proprietary hydrofluoric acid cleaner

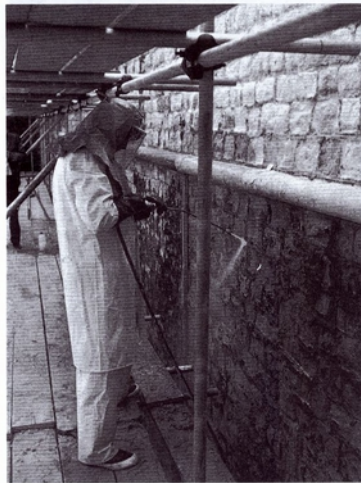
Figure 8.33 Successful cleaning with hydrofluoric acid based cleaners or any other chemical depends on a proper diagnosis of the soil type, identification of the stone/s, detailed specification based on site and laboratory trials, competent, experienced operatives and adequate supervision. In this illustration (left) the operative is properly dressed in full protective clothing, including face and hands. The water lance, a flat 15° v-jet operating at 5000 psi, is being used to remove a cleaning agent after a dwell time of five minutes. The same lance is used to pre-wet the wall before application of the cleaning agent to avoid the risk of dry stones or joints absorbing cleaning material

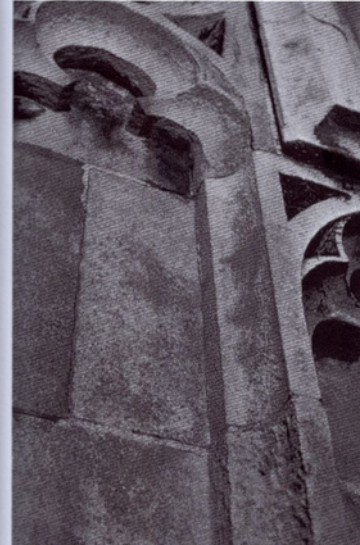
Figure 8.34 Failure to remove certain cleaning agents successfully can result in disfigurement or damage, or both. This illustration shows staining and efflorescence resulting from residues of sodium hydroxide left in limestone detail. Salt crystallisation damage is likely as wetting and drying cycles promote the distribution growth of sodium salts

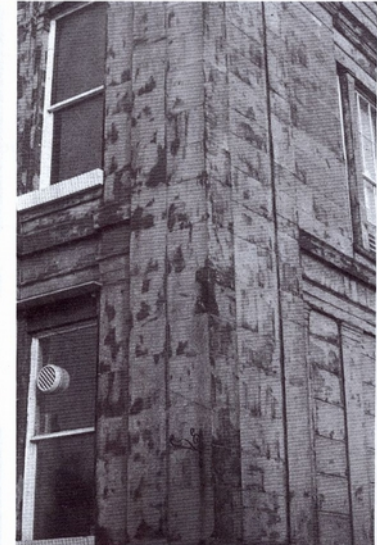
Figure 8.35 Failure to remove hydrofluoric acid will result in the formation of colloidal silica bound to the surface of the stone. This illustration shows carefully applied hydrofluoric acid formulation permanently bound to sandstone after being left for over twelve hours instead of 5–15 minutes. This disfigurement could only be removed by spinning, blasting or otherwise redressing the masonry to remove the outer 2 mm
